Green River Assessment: Report & Action Plan

**Housatonic Watershed
Green River Stream Team 2017**

Housatonic Valley Association

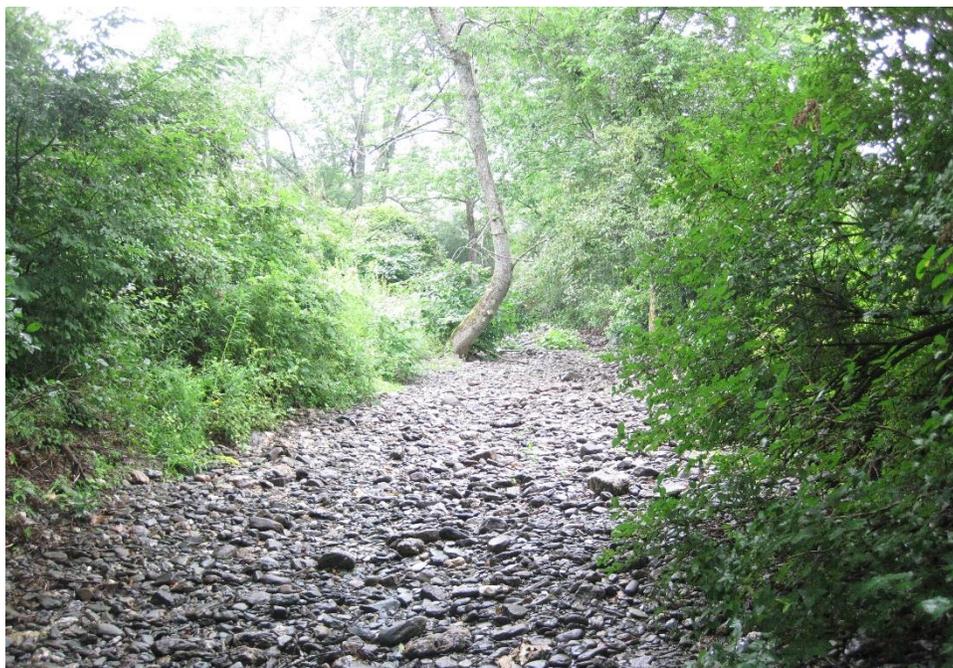
Section B was dry at the time of the survey Photo by Dylan La Chance

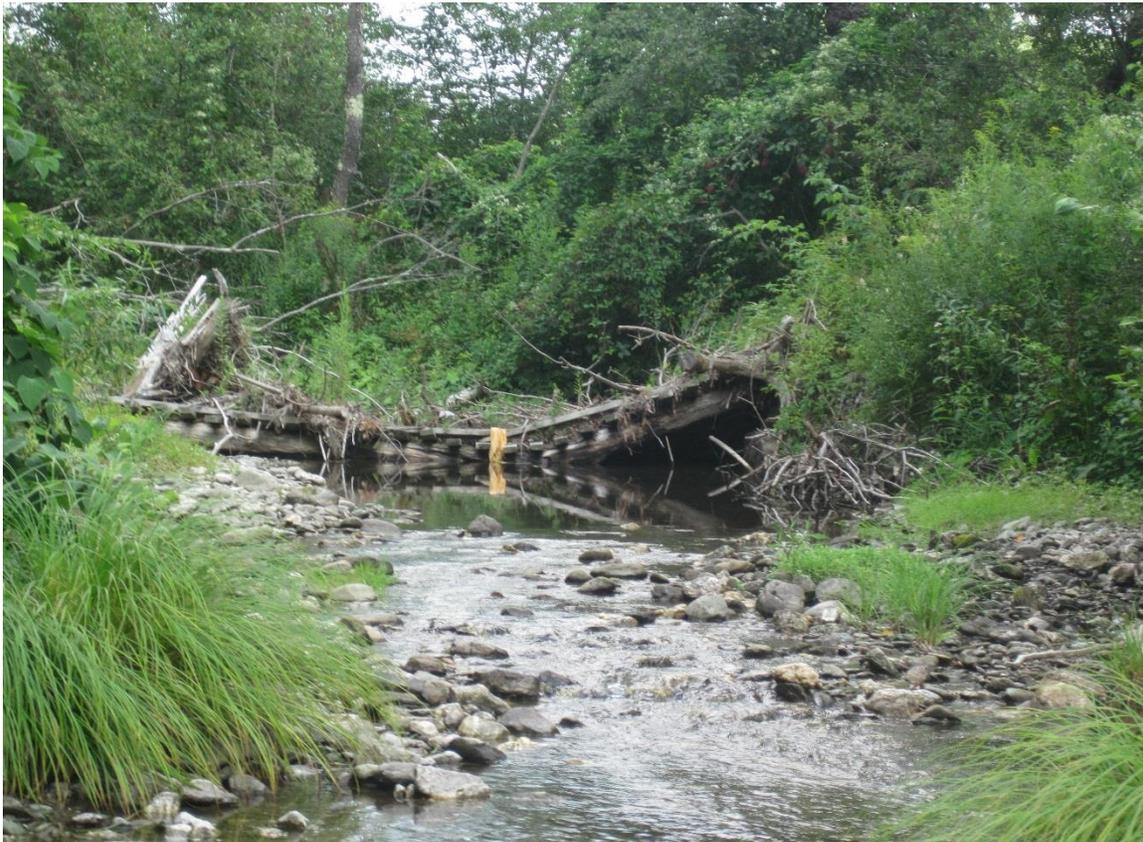
Collapsed bridge in river - photo by Dylan La Chance

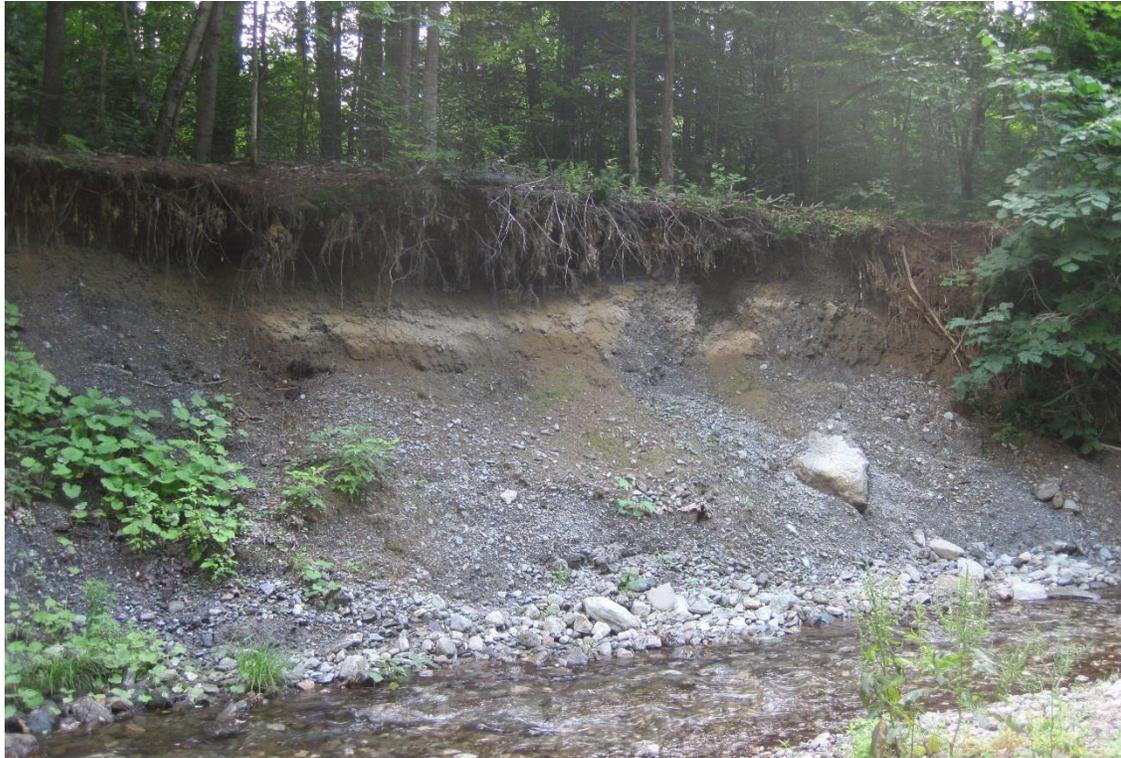
The issues along this section are similar to the previous sections and include numerous patches of invasive Japanese knotweed, bank erosion and a lack of vegetated buffer behind a couple of residential houses. Many Japanese knotweed patches were observed along the banks and gravel bars and brown algae was observed on the rocky substrate which may be invasive Didymo. Not all of the "knotweed" patches were mapped. The majority of the shoreline is forested and, as a result of bank erosion, many large blowdowns block the river. One section was severely eroded resulting in multiple trees down and in another stretch the trees down looked as if they had snapped off at about 1 – 2 feet high.

An example of the bank erosion observed – photo by Mike Murphy

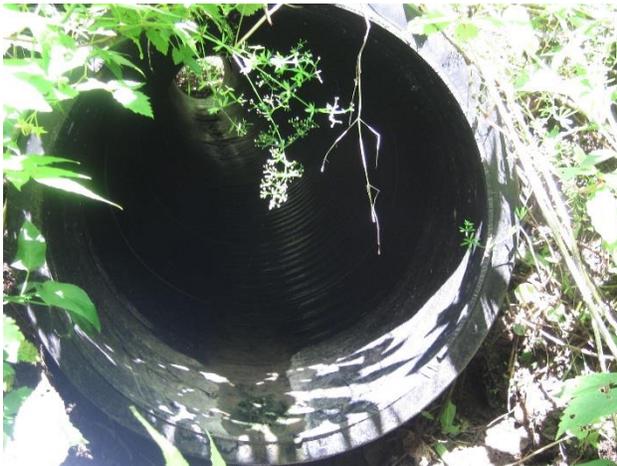
A couple of pipes (plastic; 18" diameter) that outfall to the river were noted. These pipes may be carrying stormwater from River Road to the Green River.

Two pipes observed on Section E which are possibly storm drain outfalls – photo by Dylan La Chance

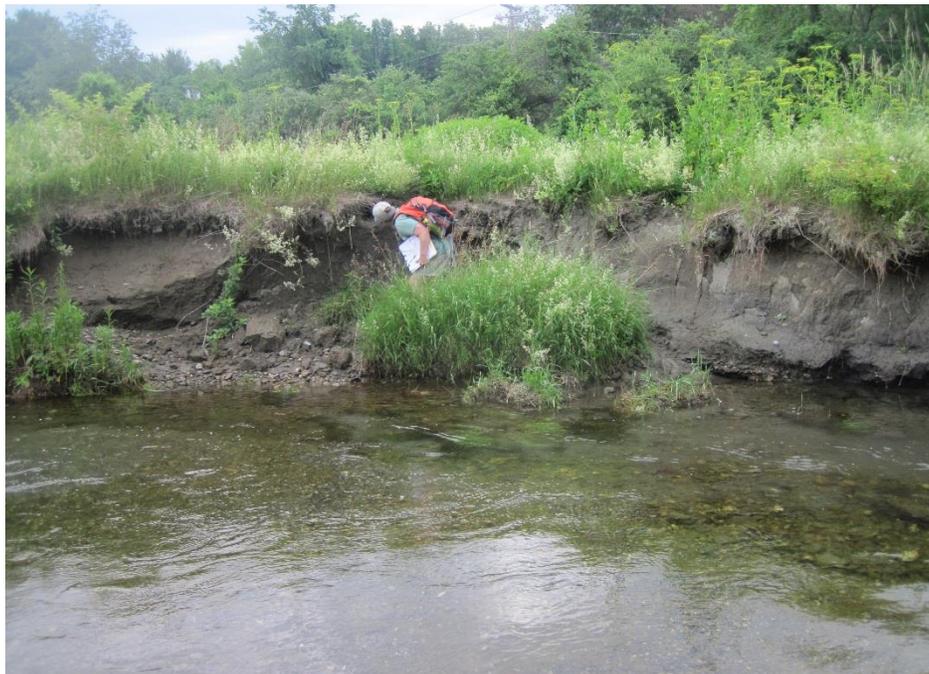
Marcia Arland, Stream Team member, investigating the eroded banks
 Photo taken by Dylan La Chance

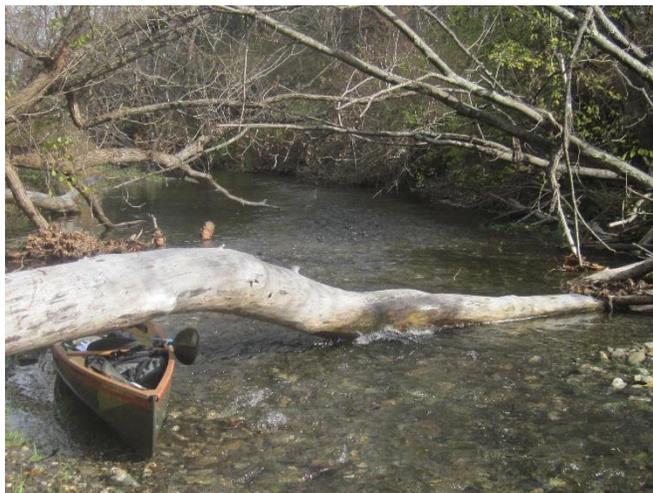
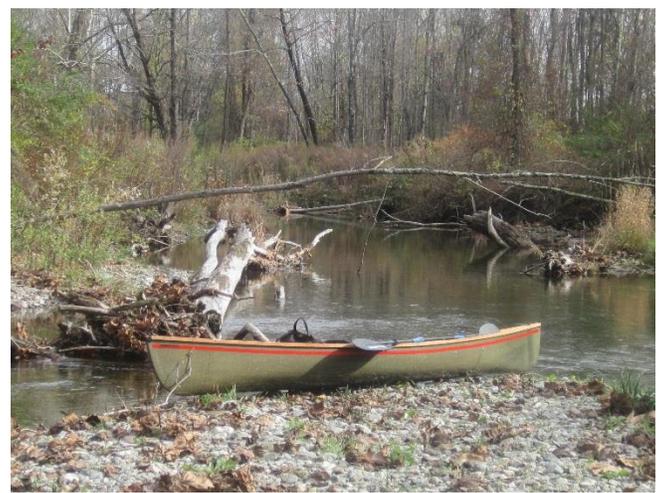
Section J had multiple trees down making it an obstacle course to paddle by canoe – photo taken by Alison Dixon

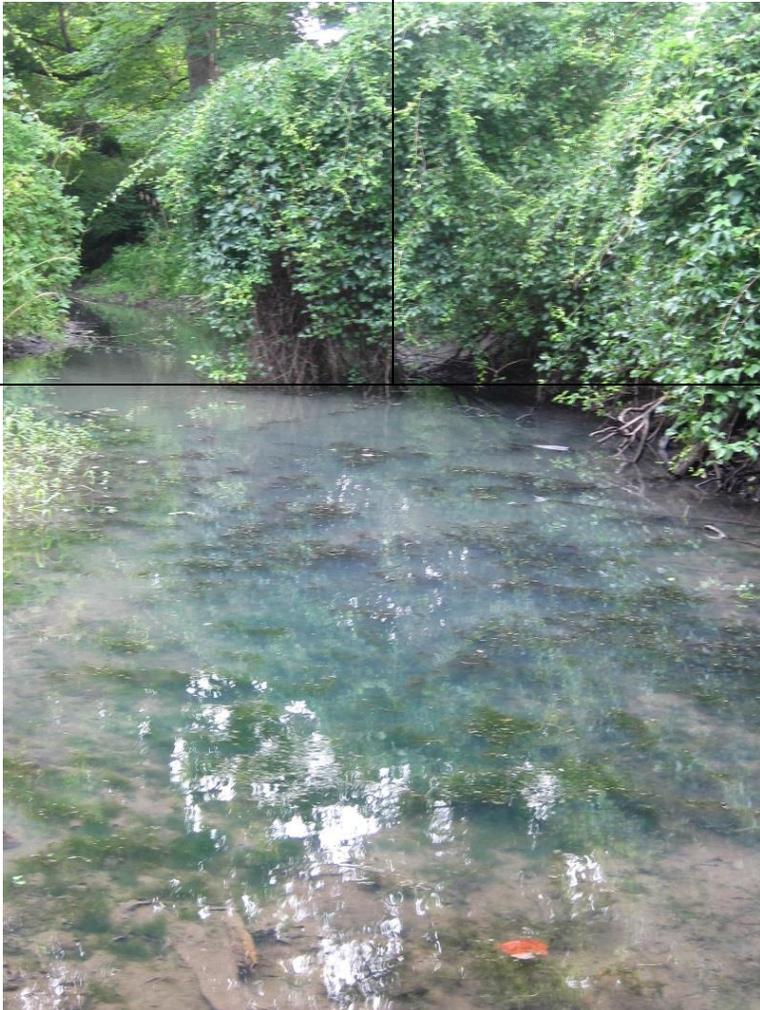
“Canal” with greyish water and full of algae – photo taken by Dylan La Chance

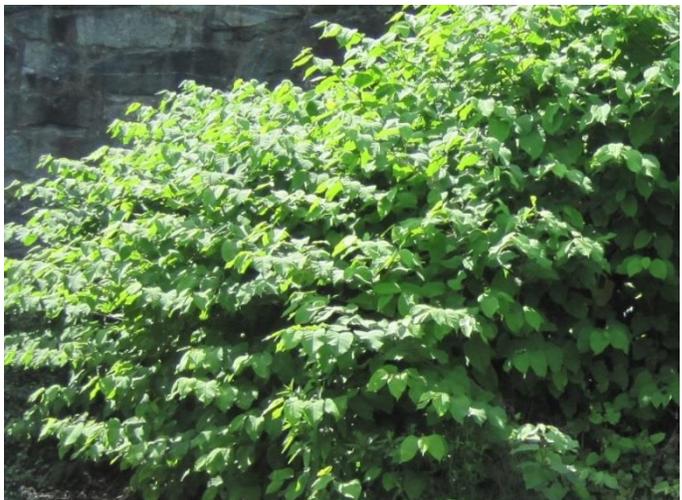
A patch of Japanese knotweed in Section G near the railroad bridge adjacent to Clapp Park on the Southwest Branch. Photo Credit: Yvonne Borsody

Do not compost plant materials as they may sprout and then spread. Piles may be burned. Do not remove soil or plant material from the site unless being disposed of in a landfill. ⁶
