Green River Assessment: Report & Action Plan

**Housatonic Watershed
Green River Stream Team 2017**

Housatonic Valley Association

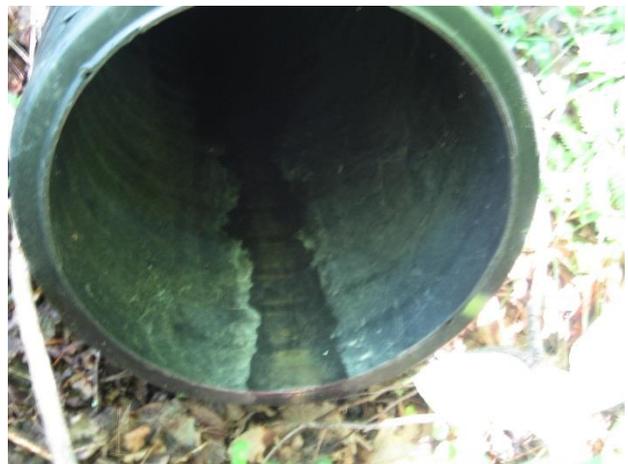
A couple of pipes (plastic; 18" diameter) that outfall to the river were noted. These pipes may be carrying stormwater from River Road to the Green River.

Two pipes observed on Section E which are possibly storm drain outfalls – photo by Dylan La Chance

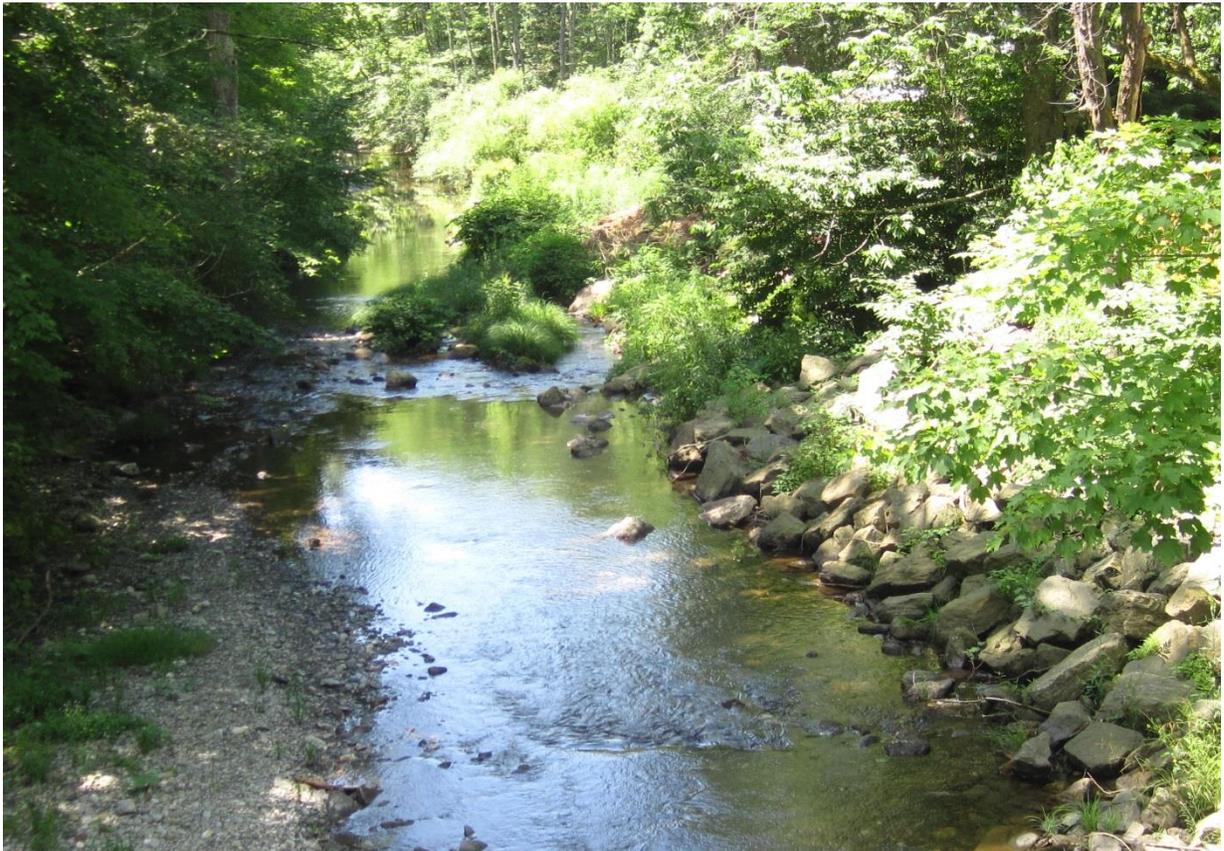
A view of the Green River along Section E - photo by Dylan La Chance

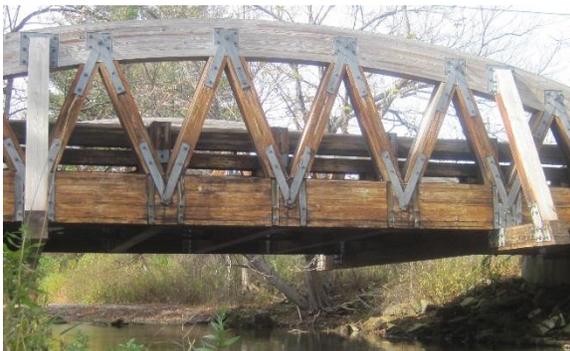
Pumpkin Hollow Road Bridge - photo by Alison Dixon (HVA staff)

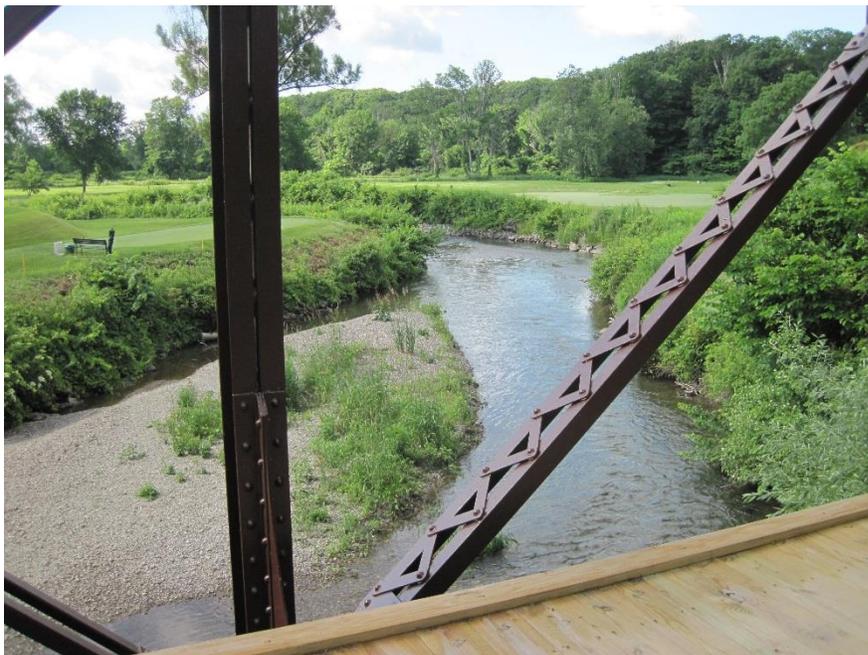
Typical of most golf courses, the greens are mowed to the river’s edge and many golf balls were seen in the river. A lack of vegetated buffer is also evident along the farm field (river right) where there is active bank erosion for about 100 yards on the river bend. In the river, near a drainage pipe from the golf course property there was a thick mat of aquatic vegetation.

A view of the golf course from the private bridge used to access Section N – photo taken by Dylan La Chance

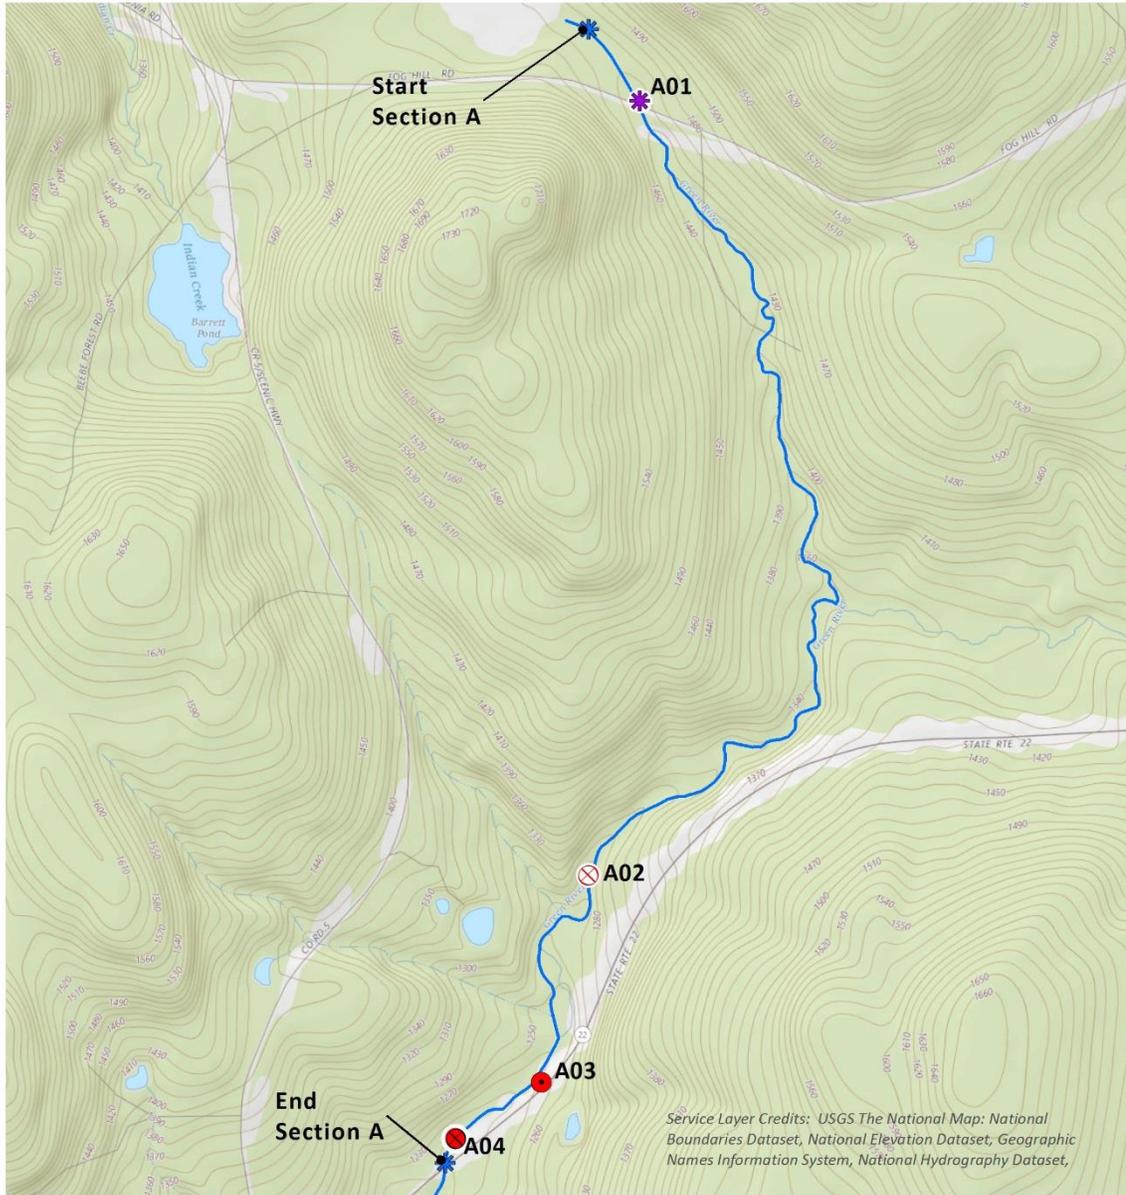
Green River Section A

CODE	GPS COORDINATES		FEATURE	NOTES
A00	42.340783	-73.462551	Beginning of Section A	Fog Hill Road crossing
A01	42.340837	-73.462525	Invasives	Upstream of crossing patch of Phragmites
A02	42.326719	-73.463347	Impediment	Trees down catching woody debris (Multiple locations)
A03	42.322915	-73.464376	Pipe	Probable storm drain outfall (Approx. coordinates obtained from Google maps)
A04	42.321531	-73.466738	Stream Impact	river right: Bank erosion on bend upstream of Rte. 22 bridge

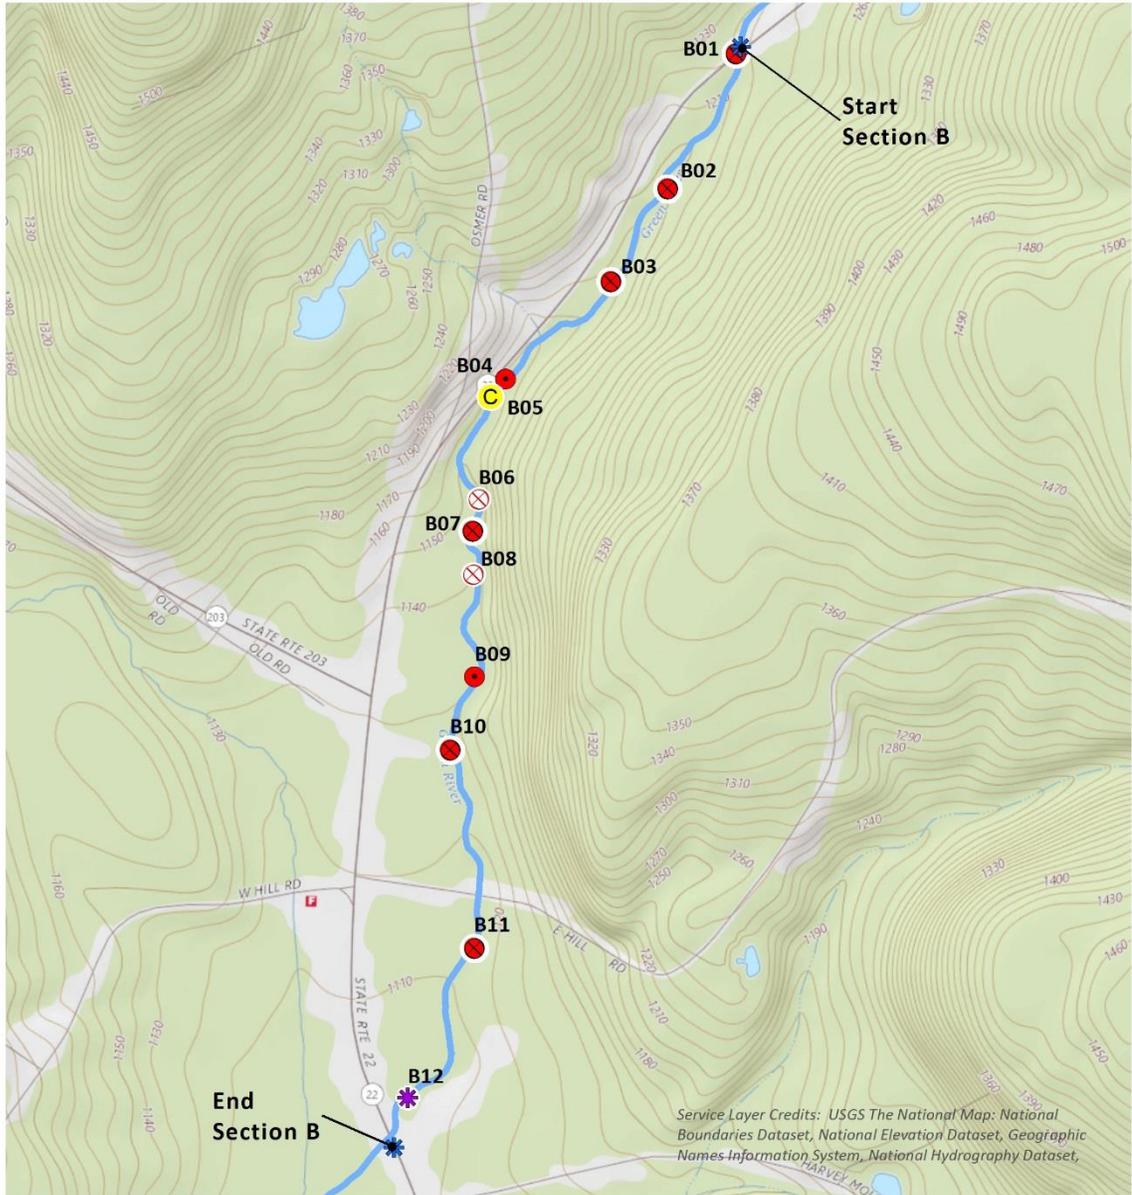
Green River Section B

B10	42.311700	-73.471740	Stream Impact	Lack of vegetated buffer: Mowing up to the bank
B11	42.309000	-73.471220	Stream Impact	Mowed edge on both sides of the river;
B12	42.306934	-73.472376	Invasives	Narrow buffer with patches of Japanese knotweed and other invasive plants

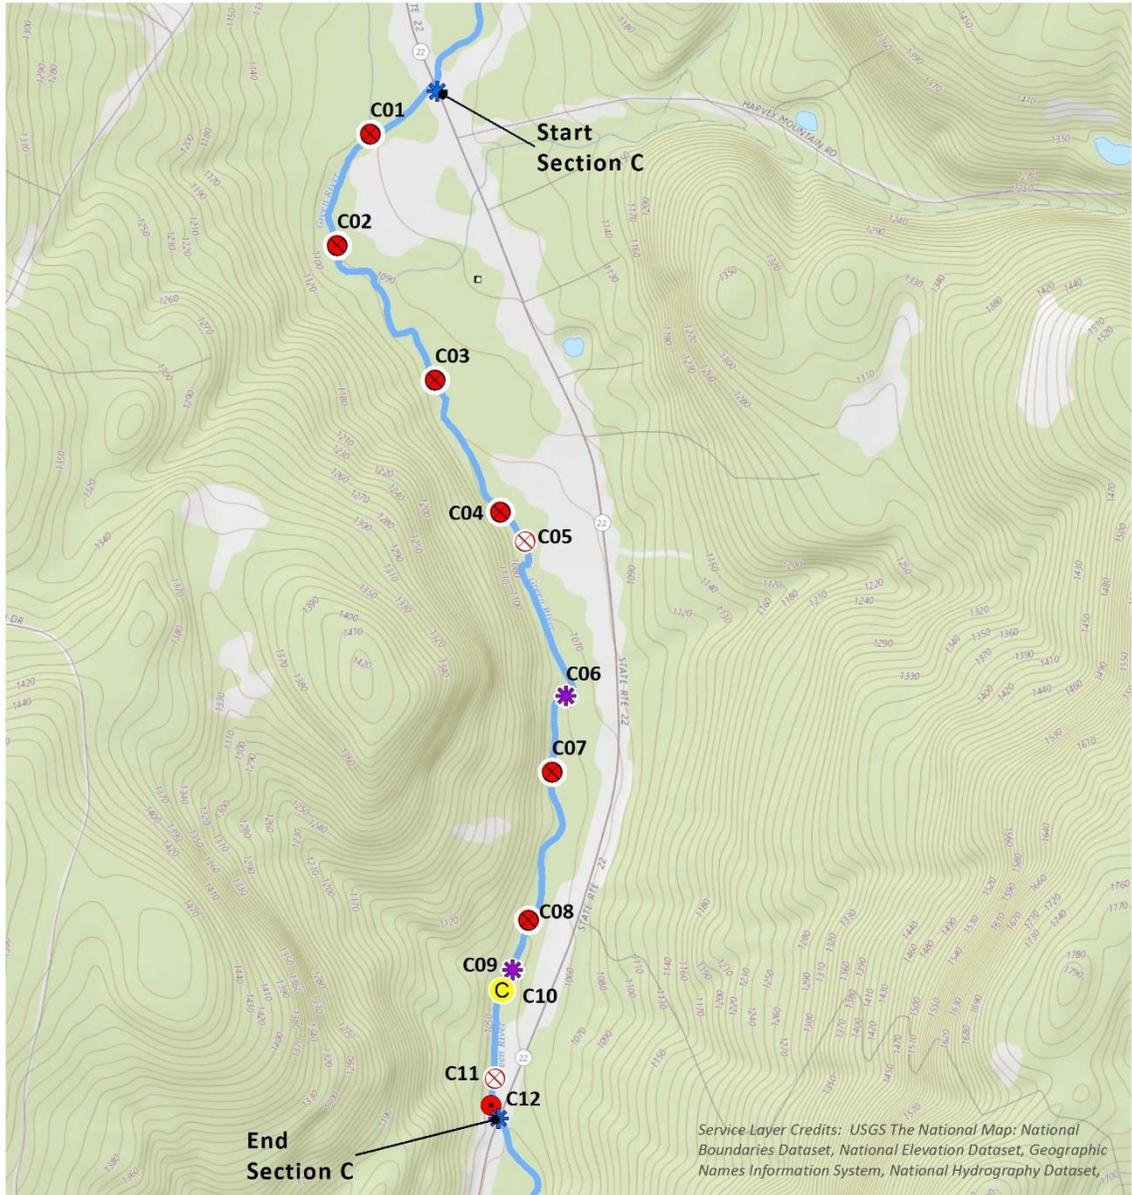
Green River Section C

C09	42.290100	-73.470400	Invasives	Japanese knotweed patch (large, river left and upstream river right)
C10	42.289900	-73.470500	Confluence	Confluence with small unnamed tributary
C11	42.288100	-73.470700	Impediment	Active beaver dam
C12	42.287799	-73.470698	Pipe	2, 4in PVC pipes protruding from bank right, dripping; some algae/sediment in pipe

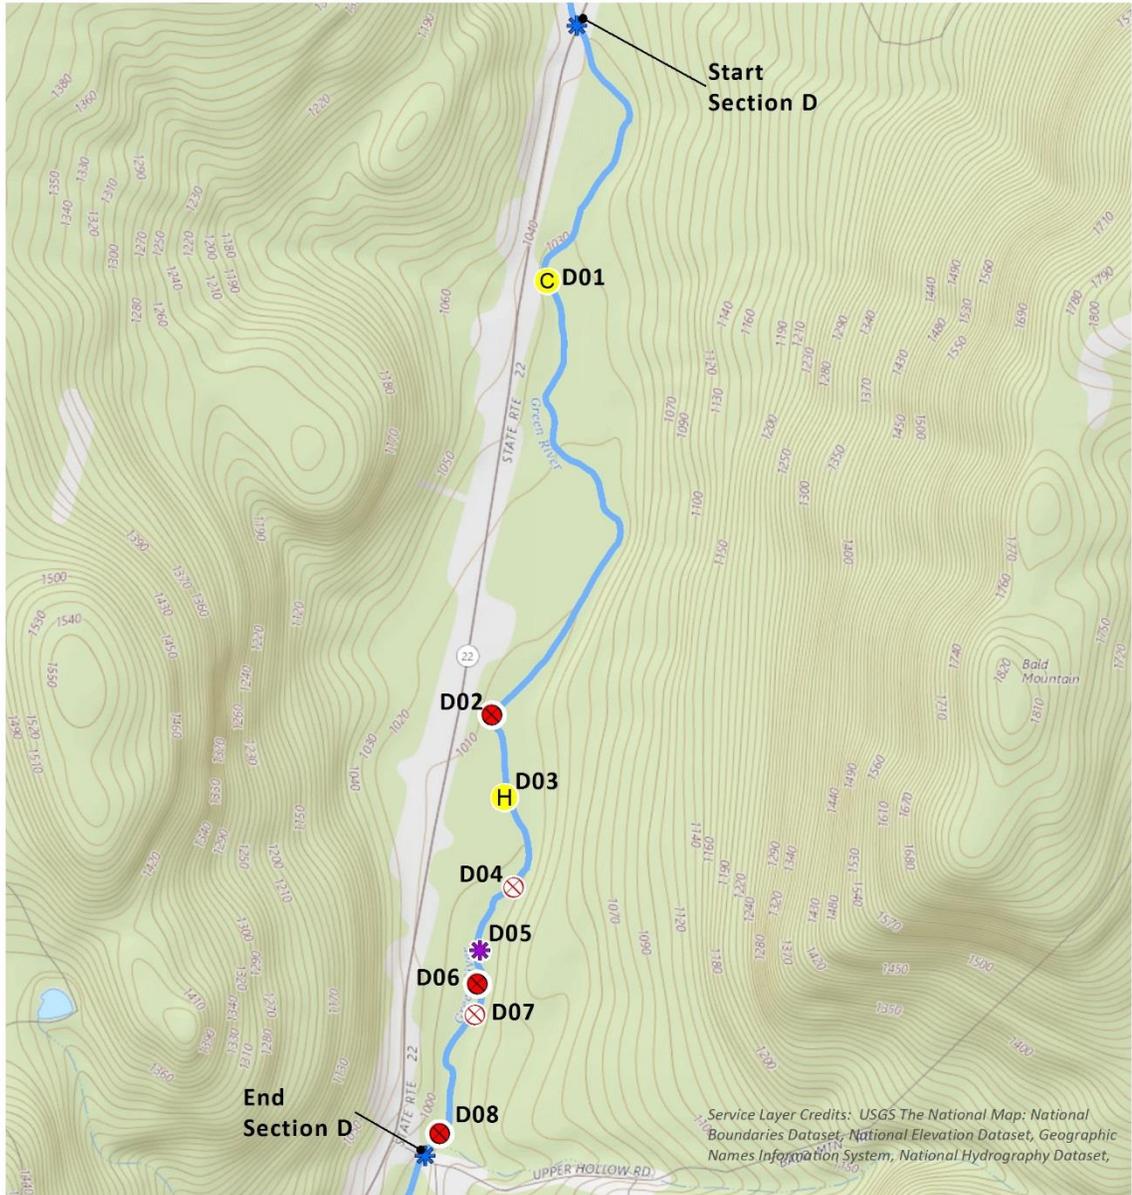
Green River Section D

CODE	GPS COORDINATES		FEATURE	NOTES
D00	42.287574	-73.470514	Beginning of Section D	Route 22 Road Crossing
D01	42.284070	-73.470950	Confluence	River right: dry tributary (culvert under Route 22 visible)
D02	42.278130	-73.471790	Stream Impact	Mowed Meadow to bank; Footbridge near by
D03	42.277000	-73.471510	Historic	Old stone bridge abutments or breached dam
D04	42.275780	-73.471320	Impediment	Multiple downed trees - snapped off - creating a large blockage
D05	42.274780	-73.471880	Invasives	2 large patches of Japanese knotweed (additional patches observed upstream)
D06	42.274450	-73.471946	Stream Impact	Severe bank erosion (20ft wide) (adjacent to downed trees)
D07	42.274270	-73.471850	Impediment	River left: large area of erosion has caused multiple trees to block stream
D08	42.271450	-73.473229	Stream Impact	River right: Narrow/Lack of vegetated buffer behind residential property

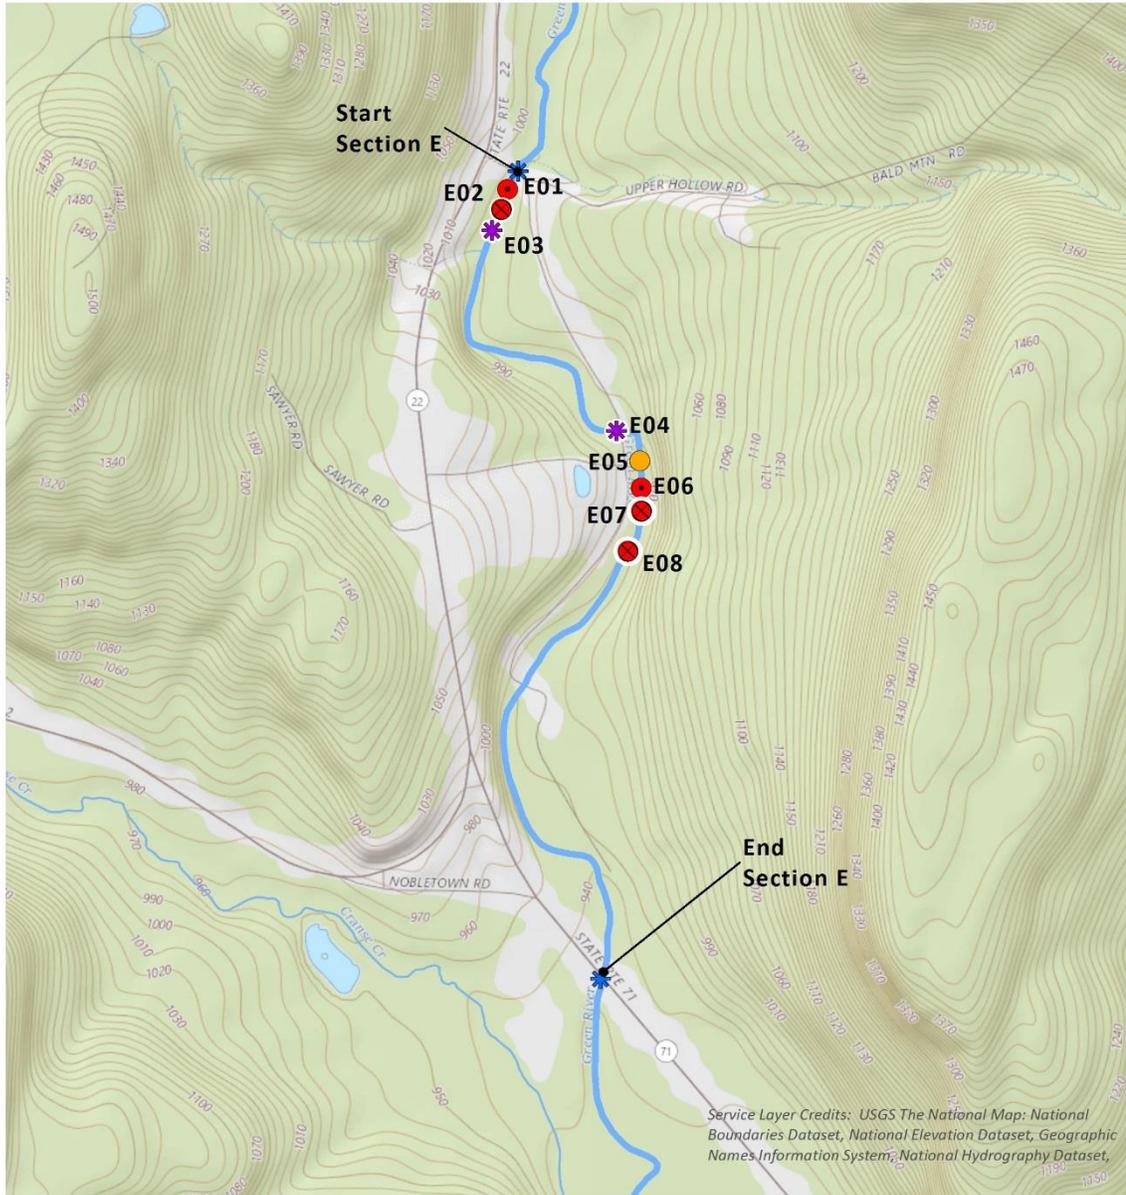
Green River Section E

CODE	GPS COORDINATES		FEATURE	NOTES
E00	42.272082	-73.472819	Beginning of Section E	Upper Hollow Road Crossing
E01	42.271860	-73.472700	Pipe	Possibly a stormwater runoff pipe (18 inch, plastic) outfalls from River Road (no flow)
E02	42.271200	-73.473390	Stream Impact	Lack of vegetated buffer: Mowing to bank (river right)
E03	42.271420	-73.473188	Invasives	Brown algae covering stream bottom - possibly invasive Didymo
E04	42.268544	-73.470700	Invasives	Japanese knotweed along bank at River Road bridge (10 ft. x 2 ft. sized patch)
E05	42.268120	-73.470260	Trash	Woody debris and Styrofoam buried in streambed
E06	42.267480	-73.470650	Pipe	Possibly a stormwater runoff pipe (18 inch, plastic) outfalls from River Road (no flow)
E07	42.267950	-73.470340	Stream impact	Hose (river left) disappears into bank
E08	42.267310	-73.470550	Stream impact	Probable runoff channel from River Road

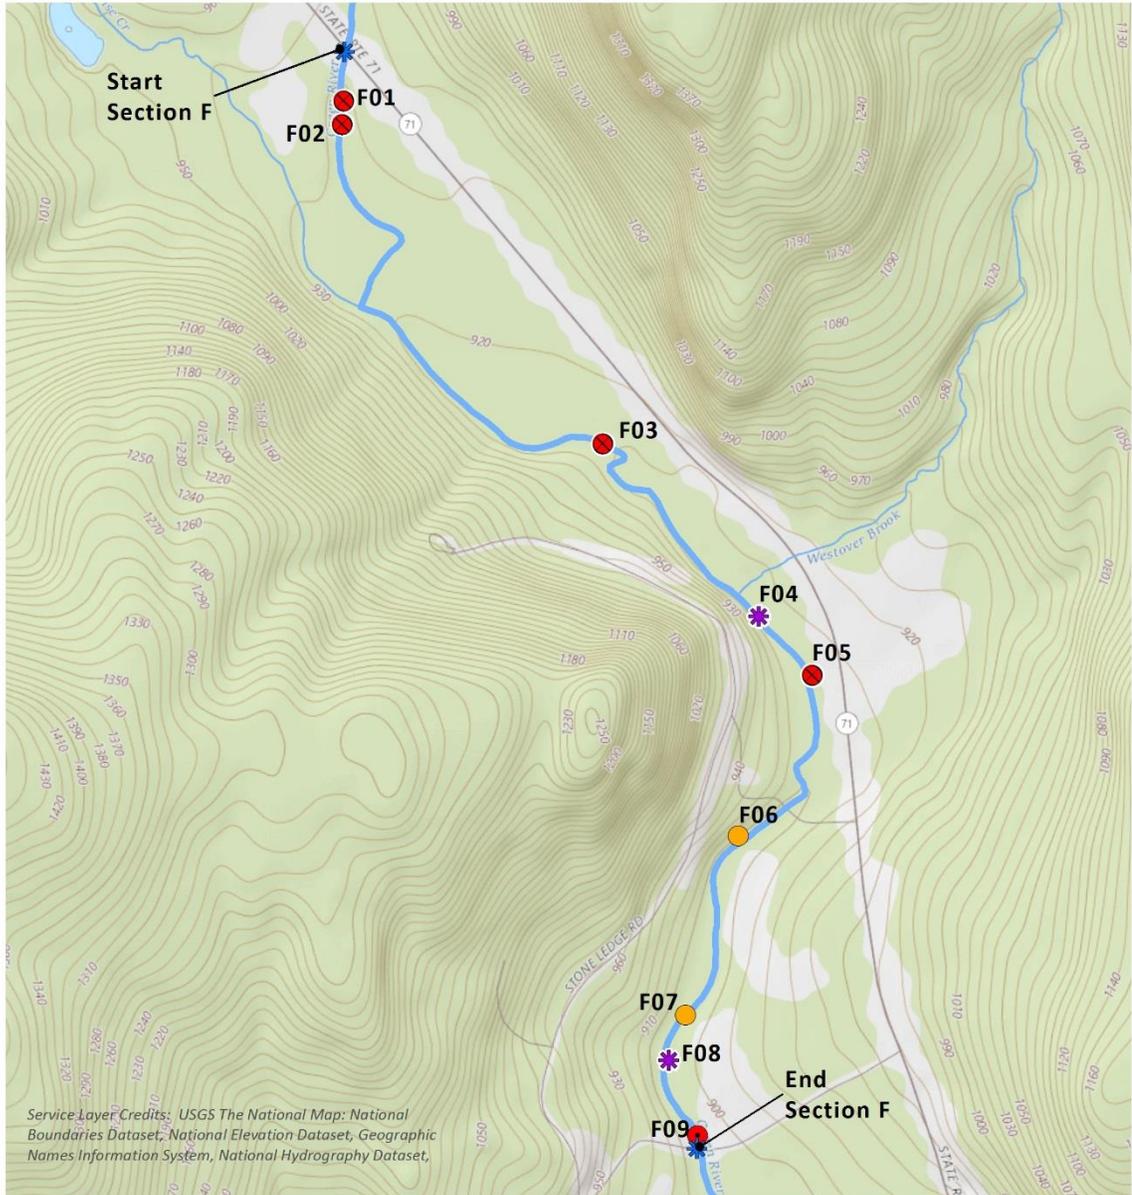
Green River Section F

CODE	GPS COORDINATES		FEATURE	NOTES
F00	42.261073	-73.470961	Beginning of Section F	Route 71 Road crossing - South of Nobletown Road
F01	42.260400	-73.470959	Stream Impact	Piling of yard debris on bank
F02	42.260080	-73.470980	Stream Impact	Lawn mowed to river's edge
F03	42.256004	-73.466010	Stream Impact	Cut trees piled at eroded river bank to help prevent further erosion (river left)
F04	42.253489	-73.463103	Invasives	Japanese knotweed
F05	42.252700	-73.462099	Stream Impact	Mowed lawn right up to river's edge
F06	42.250481	-73.463385	Trash	Defunct power line and box - across river and on west bank (river right)
F07	42.248010	-73.464280	Trash	Old metal field trash (field, river left, seems to maintain about a 25 ft. buffer
F08	42.247400	-73.464570	Invasives	Extensive patches of Japanese knotweed on the bank
F09	42.246240	-73.463920	Pipe	Storm drain outfall underneath bridge

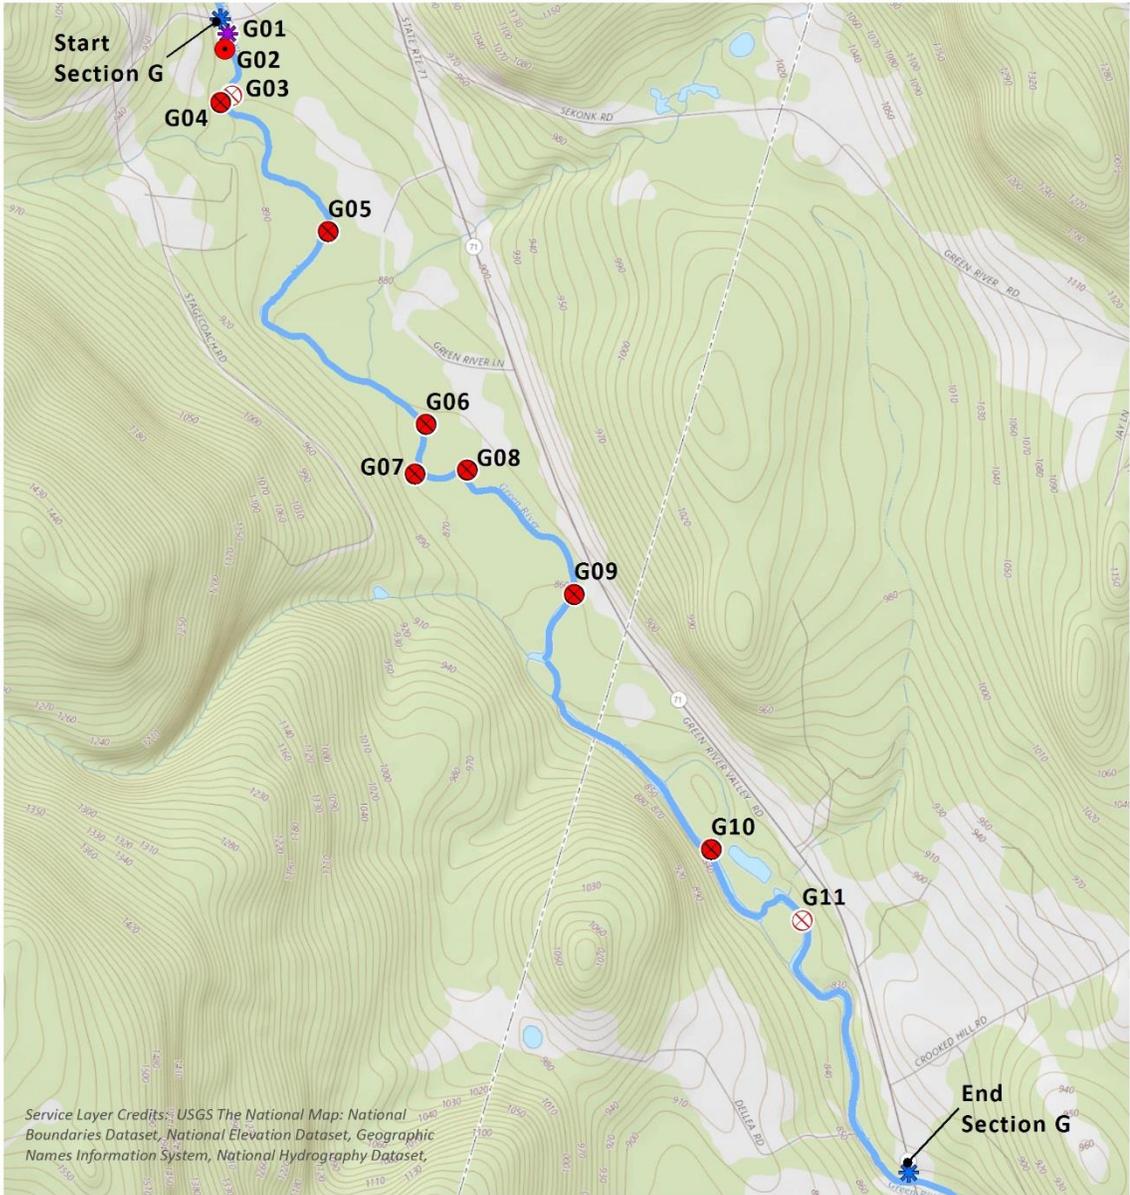
Green River Section G

G07	42.237997	-73.458994	Stream Impact	River right - lawn edge up to edge and erosion occurring
G08	42.238089	-73.457728	Stream Impact	River left: Eroding banks - gabion of rocks installed as preventative measure (homeowner is trying to protect land from eroding away
G09	42.235872	-73.455030	Stream Impact	River left: Eroding bank was shored up with riprap (mowed?) very near Route 71 - farm field fenced in
G10	42. 233522	-73.447830	Stream Impact	Below driveway bridge - Possible discharge from unused agricultural pond - brown and slimy covering the river substrate or Didymo? Would need further investigation
G11	42.229915	-73.449861	Impediment	Downed trees completely blocking passage: Surveyors couldn't get beyond this blockage

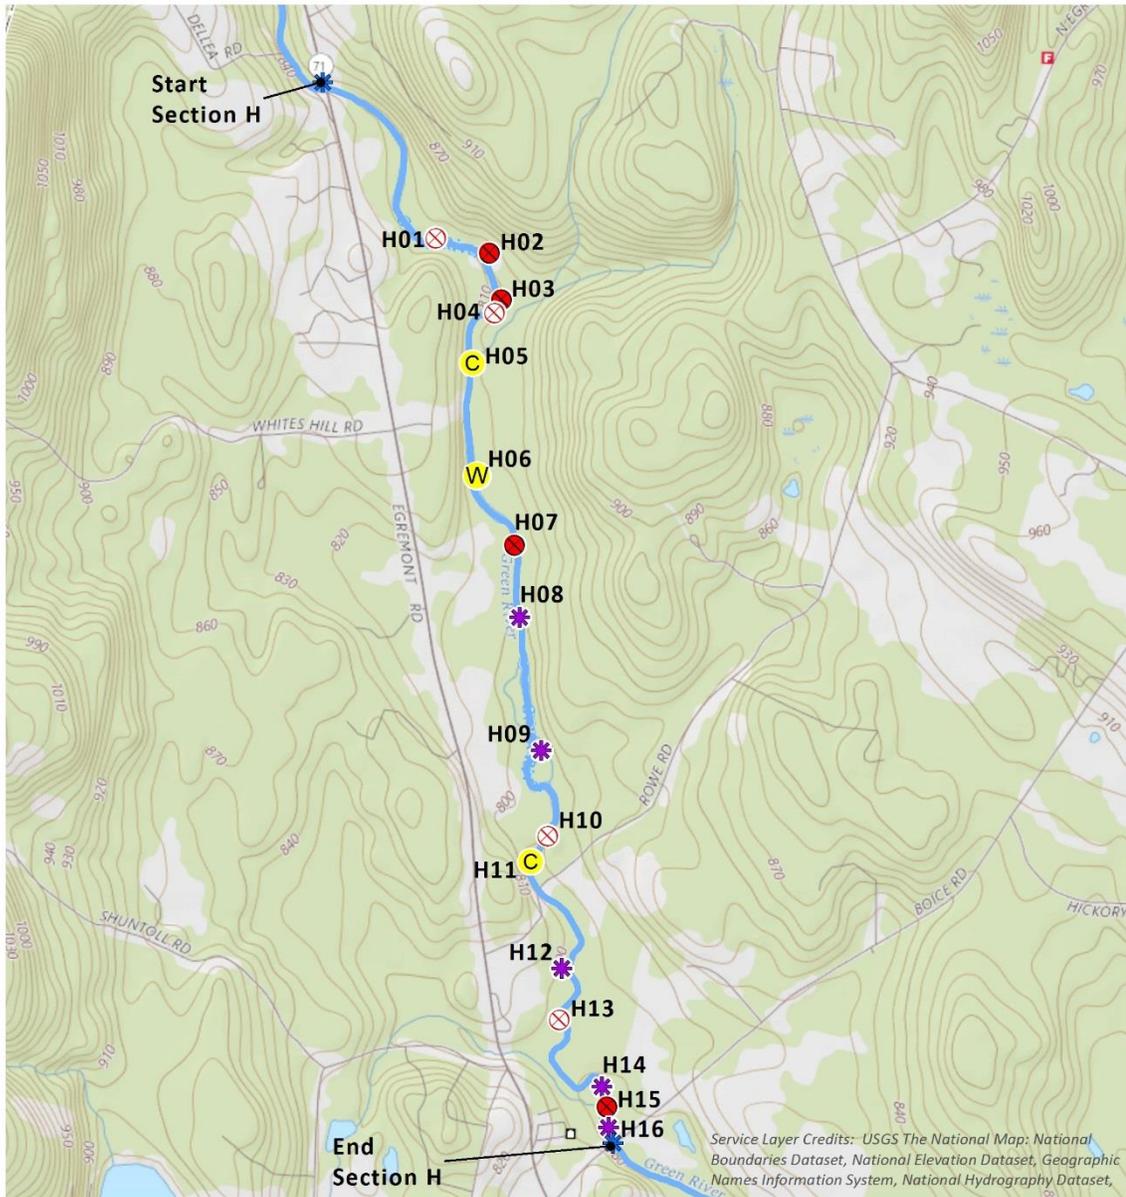
Green River Section H

H12	42.204080	-73.438030	Invasives	Japanese knotweed on islands in the channel; multiflora rose on banks (smaller bushes)
H13	42.202840	-73.438090	Impediment	Downed tree; Japanese knotweed colonized sand bar (much native flora as well)
H14	42.200719	-73.436328	Invasives	Japanese knotweed extensive on sand bar and east branch for about 200yds (Also multiflora rose, bittersweet and dead Black gum and ash trees)
H15	42.200057	-73.436420	Stream Impact	Undercut bank
H16	42.200010	73.436360	Invasives	Japanese knotweed (both banks 20 x15ft) & Multiflora rose extensive

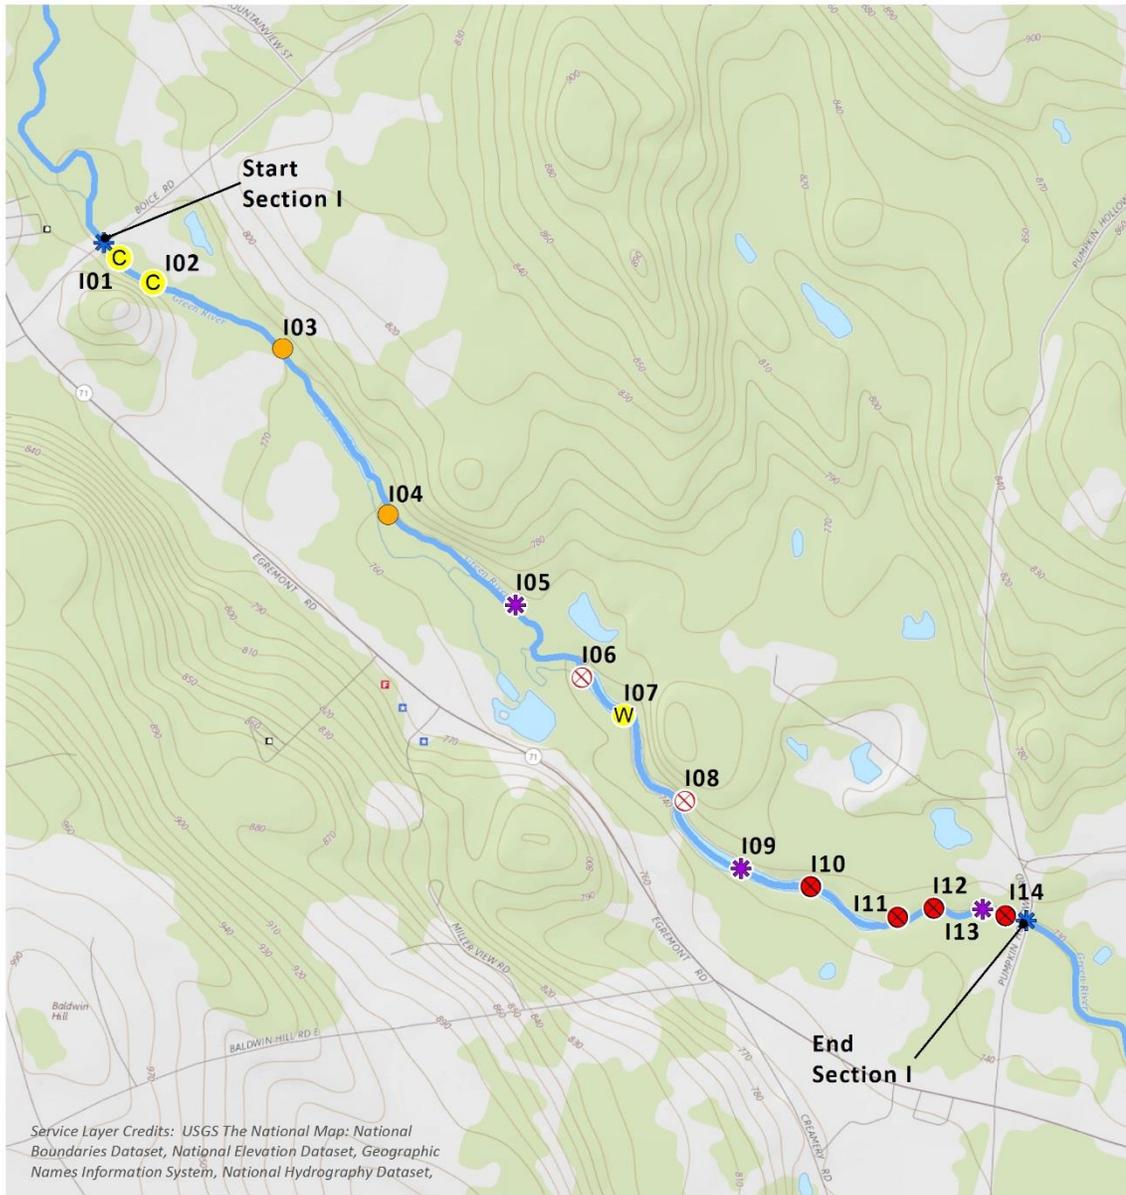
Green River Section I

I11	42.187900	-73.416400	Stream Impact	Lack of vegetated buffer; Mowing to bank (river right); Not much erosion; Multiflora rose also seen in this area
I12	42.188370	-73.414040	Stream Impact	Mowed field to edge of river -- bank erosion occurring
I13	42.188000	-73.416100	Invasives	Japanese knotweed
I14	42.187900	-73.413600	Stream Impact	Lack of vegetated buffer and bank erosion

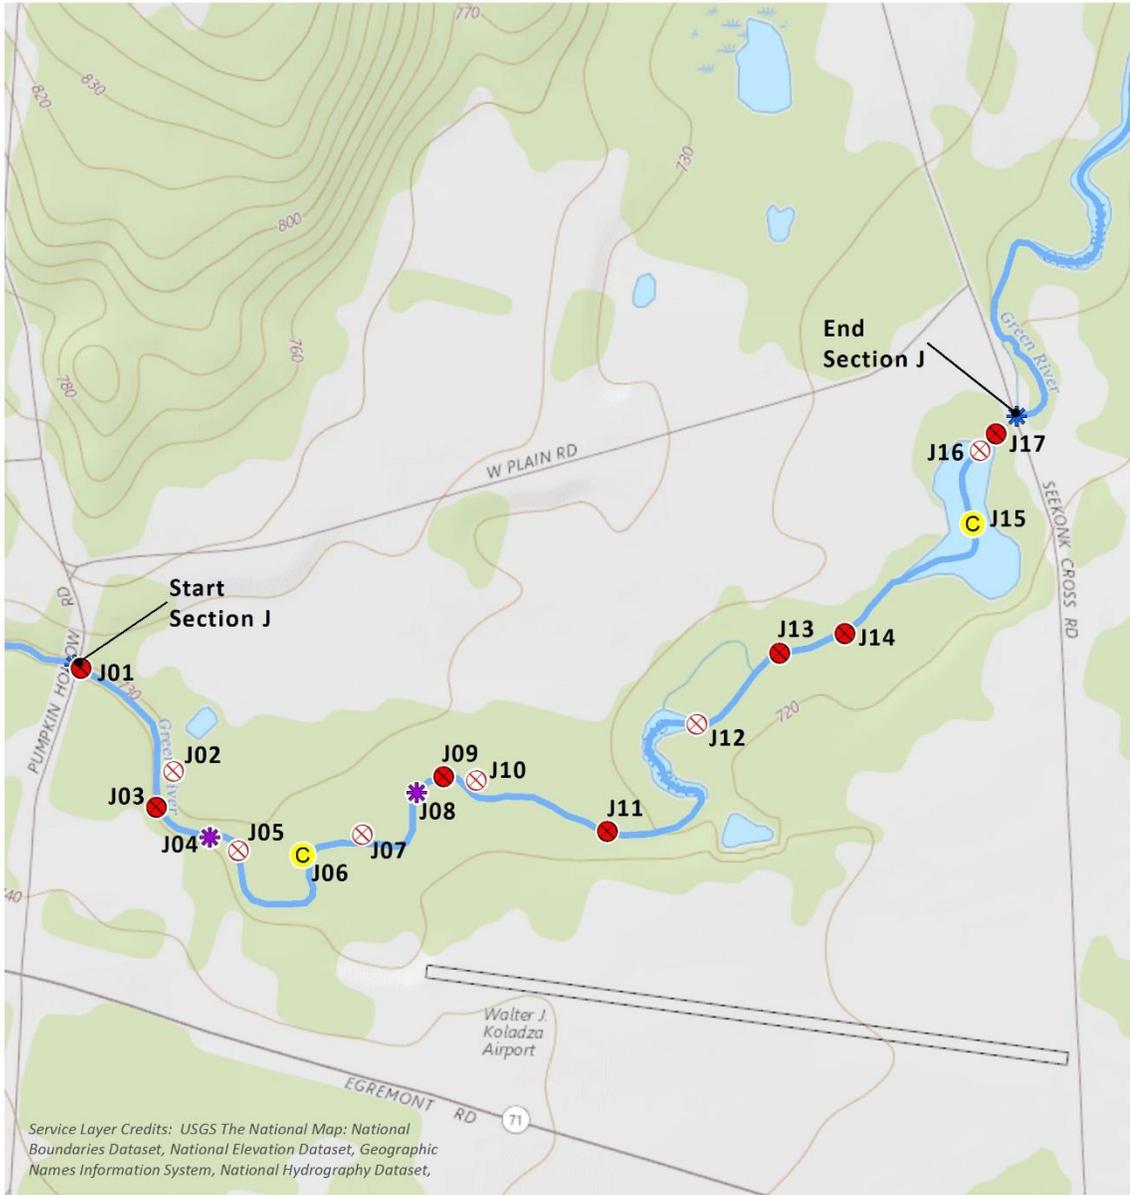
Green River Section J

J09	42.187012	-73.407831	Stream Impact	Bank erosion - minor amounts here and additional places along the section even where there is forested buffer
J10	42.186727	-73.407311	Impediment	Multiple trees down blocking passage
J11	42.186200	-73.405367	Stream Impact	Vegetated buffer narrows considerably; sumac visible on edge; banks become steep (6-8ft) some erosion
J12	42.186804	-73.403419	Impediment	Multiple trees down - some fully and others only partially across
J13	42.188395	-73.402922	Stream Impact	Mowed field to river's edge (might be providing private access). Some bank erosion evident
J14	42.188665	-73.402110	Stream Impact	Mowed field to river's edge
J15	42.189639	-73.399833	Confluence	River left: Unnamed tributary - may just drain wetland area
J16	42.190387	-73.399790	Impediment	Multiple trees blocking river (Winged euonymus observed)
J17	42.190637	-73.399787	Stream Impact	Drainage channel - looks manmade (on Google Earth can see standing water next to the field)

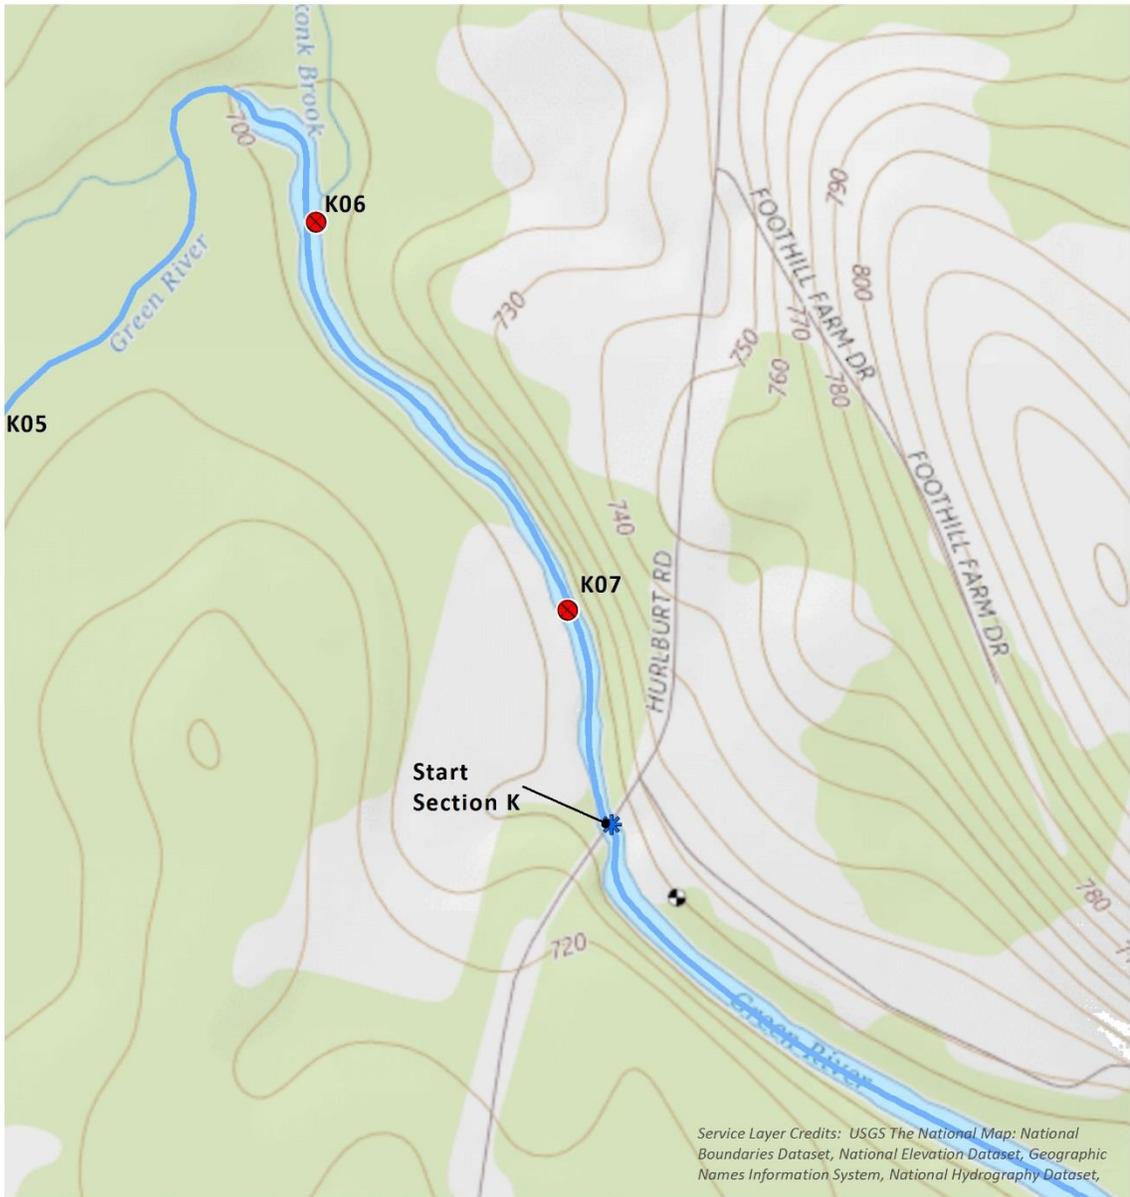
Green River Section K

CODE	GPS COORDINATES		FEATURE	NOTES
K00	42.190734	-73.399574	Beginning of Section K	Seekonk Cross Road crossing
K01	42.191392	-73.398805	Stream Impact	Lack of vegetated buffer; farm field mowed up to river's edge (about 250 feet on the bend) (river right)
K02	42.191839	-73.399931	Stream Impact	Seekonk Cross Road borders river/ river likely eroding road
K03	42.192530	-73.39836	Invasives	Japanese knotweed (approx. patch size 20ft X5ft)
K04	42.192910	-73.39825	Impediment	Downed trees across river
K05	42.195130	-73.39733	Impediment	Lots of downed trees; electric fence/ fireplace as well
K06	42.196900	-73.39435	Stream Impact	Standing water, cloudy, sewage smell, Lots of algae
K07	42.194170	-73.39180	Stream Impact	Bank erosion

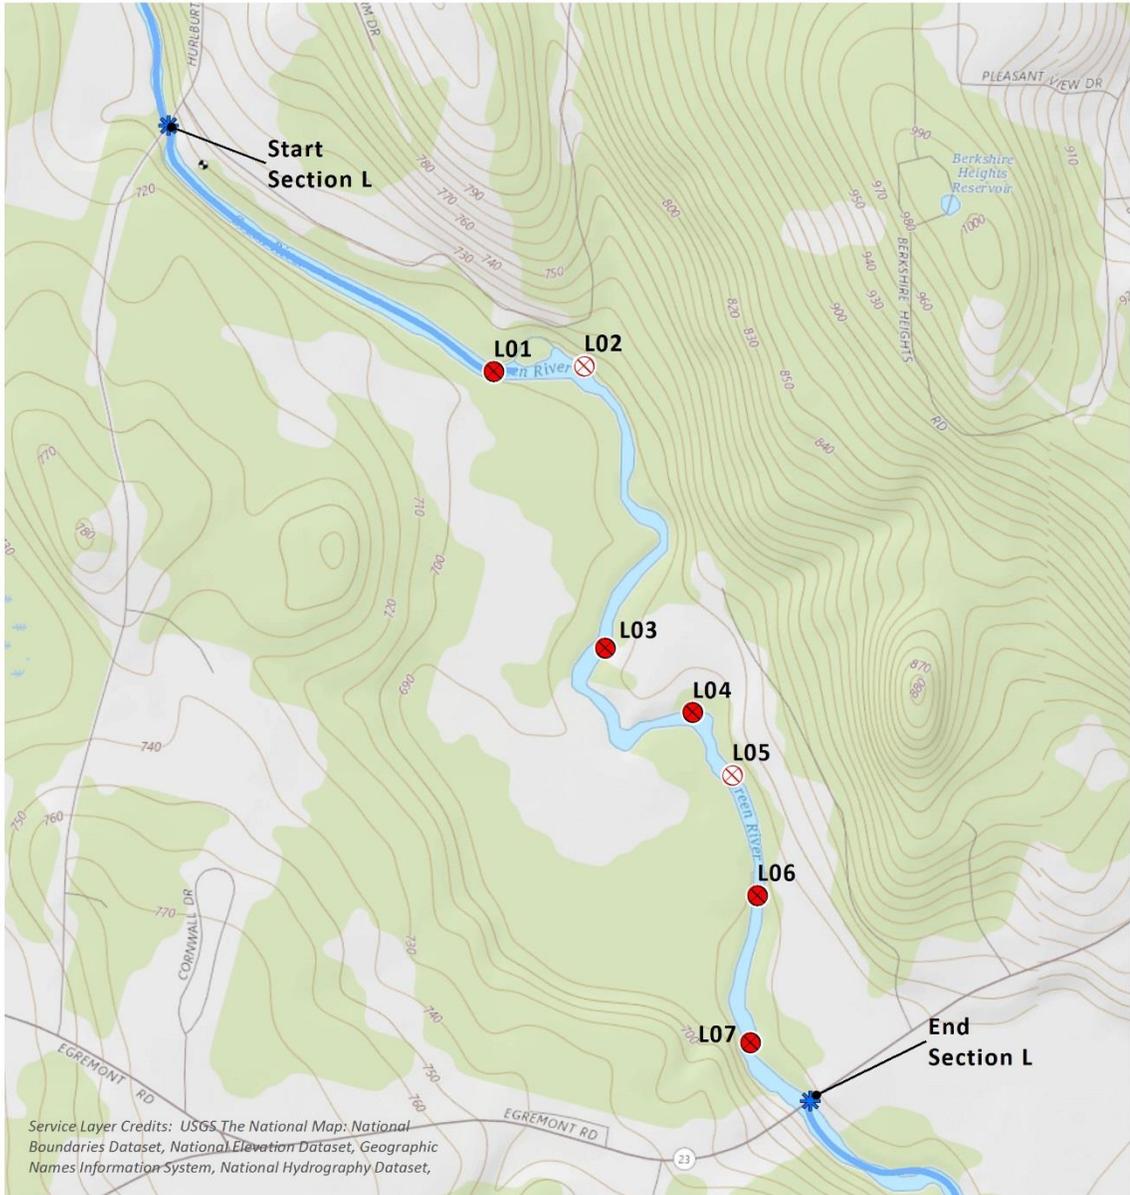
Green River Section L

CODE	GPS COORDINATES		FEATURE	NOTES
L00	42.192747	-73.391267	Beginning of Section L	Hurlburt Rd Bridge; Flow gage under bridge
L01	42.189293	-73.385246	Stream Impact	130 foot eroded bank; Lack of vegetated buffer
L02	42.189395	-73.383588	Impediment	Manmade dam downstream of "pump house spot"
L03	42.185542	-73.383087	Stream Impact	Fence falling into river due to eroded bank, lack of vegetated buffer along field
L04	42.184915	-73.381347	Stream Impact	Erosion around bend in river; Lack of vegetated buffer
L05	42.183850	-73.380700	Impediment	Beaver dam; looks recently constructed
L06	42.182210	-73.380190	Stream Impact	Bank erosion (river left) not much of a buffer between river and corn field
L07	42.180200	-73.380260	Stream Impact	Algae filled canal: Water appears to be grey/cloudy with thick with algae and vegetation

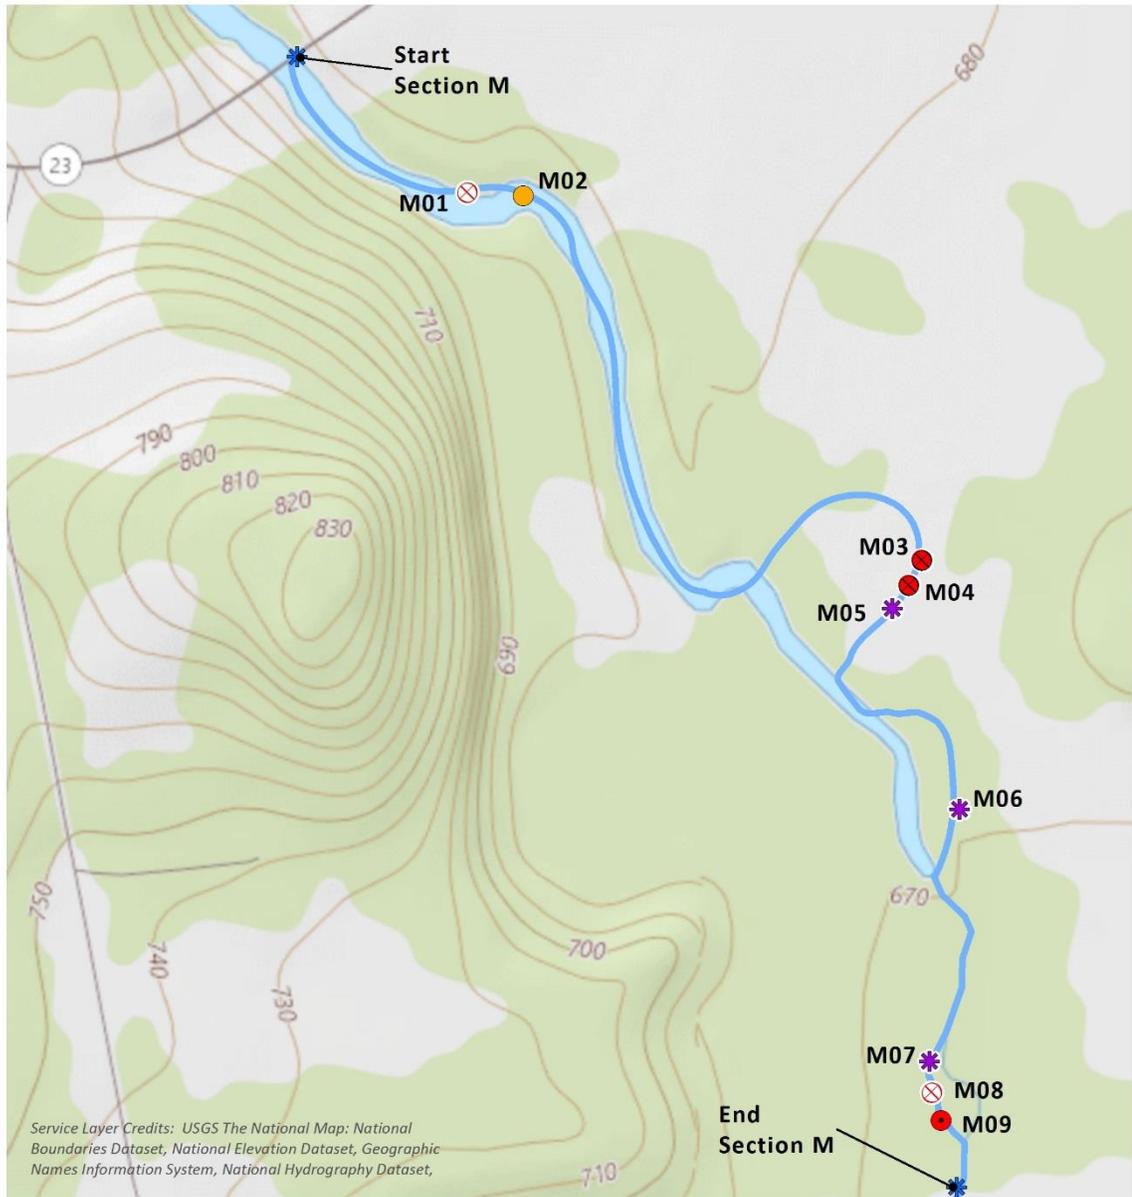
Green River Section M

CODE	GPS COORDINATES		FEATURE	NOTES
M00	42.179418	-73.379131	Beginning of Section M	Maple Avenue bridge (which is Rte.. 23/41)
M01	42.178460	-73.377440	Impediment	Manmade dam created with large rocks
M02	42.178440	-73.376890	Trash	Fire pit with associated trash
M03	42.175850	-73.372910	Stream Impact	Corn planted right up to river's edge; bank eroding
M04	42.175560	-73.372760	Stream Impact	Runoff from field creating a gully
M05	42.175680	-73.373130	Invasives	Brown algae in stream bed possibly Didymo
M06	42.174067	-73.372317	Invasives	Japanese knotweed from river bank creeping into corn field, large patch of Japanese knotweed visible in middle of cornfield from left bank
M07	42.172126	-73.372760	Invasives	Japanese knotweed approx. size patch 10ft X10ft
M08	42.171975	-73.372695	Impediment	Downed trees blocking river
M09	42.171830	-73.372700	Pipe	Possible buried pipe
