Green River Assessment: Report & Action Plan

**Housatonic Watershed
Green River Stream Team 2017**

Housatonic Valley Association

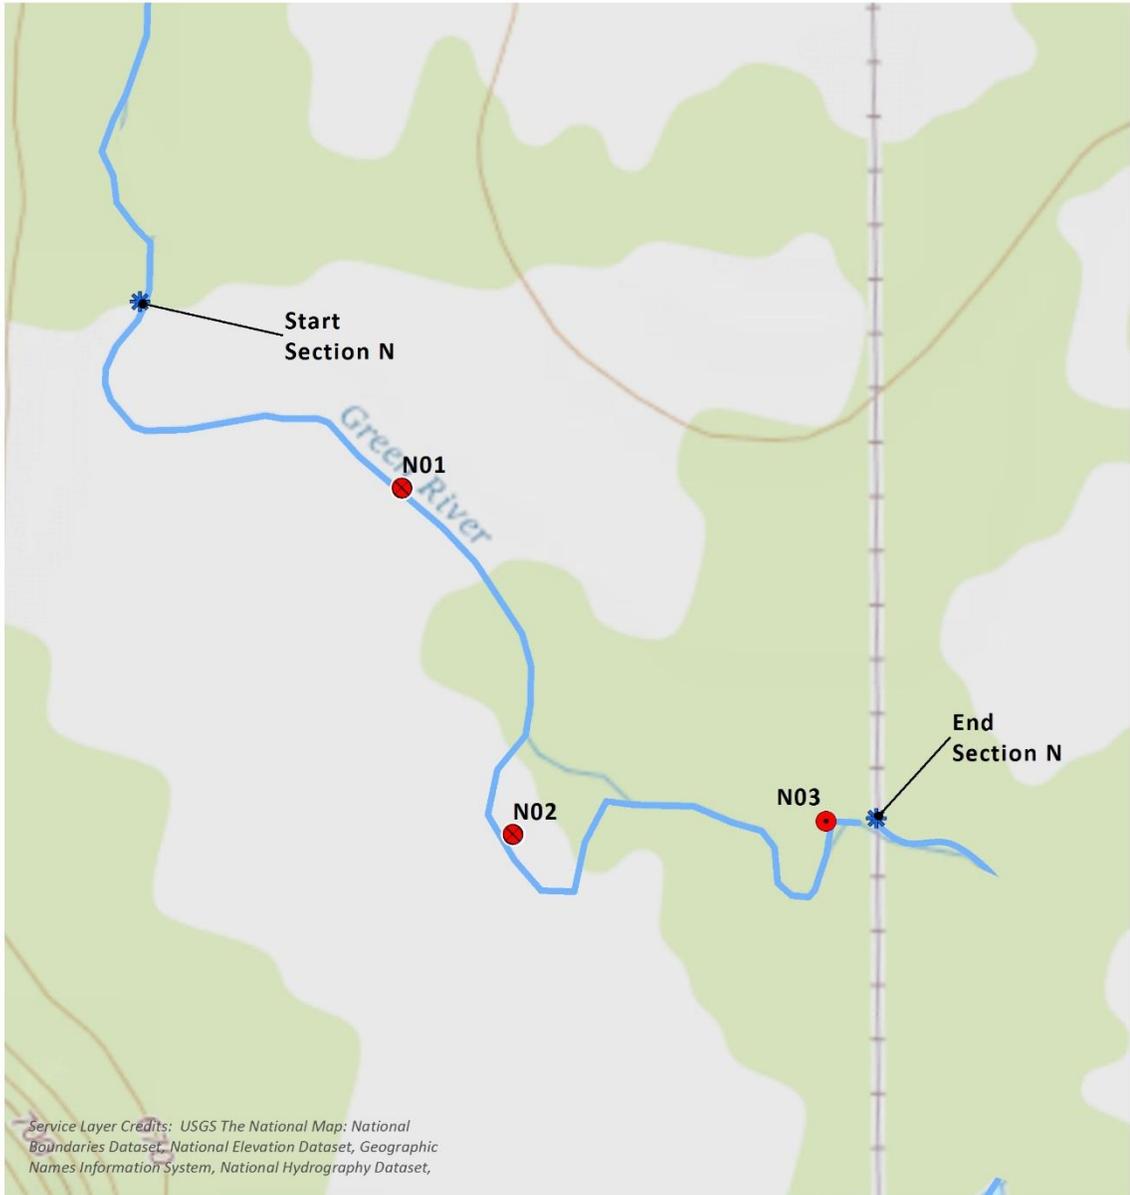
Green River Section N

CODE	GPS COORDINATES		FEATURE	NOTES
N00	42.171286	-73.372432	Beginning of Section N	Bridge on Wyantenuck Golf Course Road.
N01	42.170300	-73.370480	Stream Impact	Golf Course, sparsely vegetated buffer (about 75 ft. of bank), fish observed; many golf balls in the river.
N02	42.168480	-73.369450	Stream Impact	Large area of erosion; Lack of vegetated buffer along cornfield
N03	42.168600	-73.367310	Pipe	Drainage from Wyantenuck Golf Course; Thick aquatic vegetation in drainage area, whereas it was sparse for the rest of the section.
